## Failure Analysis of DIP SPM-01-Core Loader Cylinder Adjusting Screw

### **Abstract:**

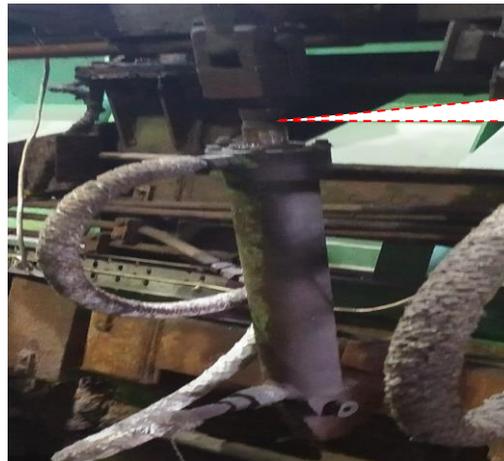
Picture :1 Location of the broken screw.

This screw broke

1. The core loader unit was changed on 7<sup>th</sup> May during monthly shut down.(picture :1)
2. After replacement it had one failure at the cylinder cushioning system.
3. The screw that failed had cylindrical head and not a hexagonal head, ( picture :2)
4. The length adjustment is done with a pipe wrench as the head is cylindrical.
5. There is very less space to accommodate the pipe wrench.

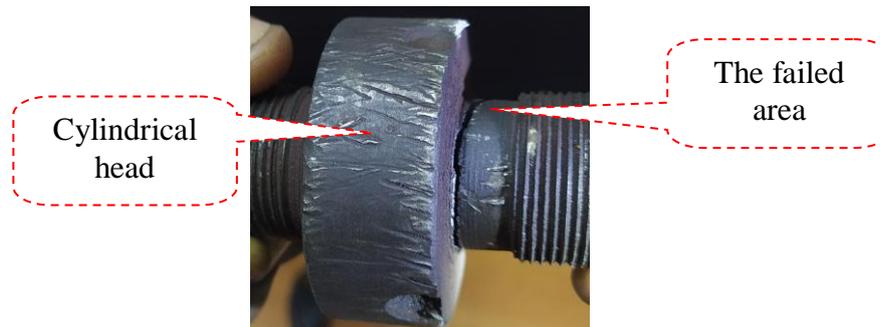
Picture:2 The failure zone

Cylindrical head

The failed area

The macro analysis of the failure reveals an abrupt breakage . No evidence of fatigue failure	<u>This indicates that the screw material was not of ductile nature but brittle probably due to heat treatment of the screw.</u>

Macro analysis shows the crack initiated at the root as shown in the picture,	<u>This is because no stress relieving radii were given during the screw machining.</u>

There were no stress relieving radii was given during machining.	<u>This absence of radii has caused the initiation of the crack .</u>

Deep tool mark on the screw. The tool mark is of the pipe wrench while adjusting the screw as per requirement.	<u>From the tool mark the crack has initiated and propagated.</u>

1. Analysis (red letters) indicate that the LH/RH screw had failed from the sharp corner of the step down as no stress relieving radii were given during machining.
2. The crack initiated at the sharp corner through the tool marks generated by the jaw teeth of the pipe wrench that was abundantly used to adjust the screw length as instead of the normal hexagonal head the LH/RH screw had a cylindrical head.
3. The macro analysis shows that the failure was a brittle nature.. As soon as the crack had generated the screw failed immediately on load.

1: No radii were given during machining to the sharp corner at the step down to relieve the stress concentration at sharp edges.

2: As the screw had round head instead of hexagonal head tool marks from the jaw teeth of the pipe wrench had initiated the crack propagation.

1. In all sharp corners always provided the normal radii to avoid stress concentration.
2. Always have hexagonal head (see figure :3) for LH/RH screw for ease of adjusting with a standard SE/DE spanner
3. Check in all equipment specially in the core loader of the spinning machines that none of these round head screws without stress relieving radii are used. Replace them with hexagonal head properly machined screws.
4. Wherever possible use check nuts of appropriate width to suit at site.
