## Failure Analysis of DIP SPM-01-Mould Roller Drive Bearing

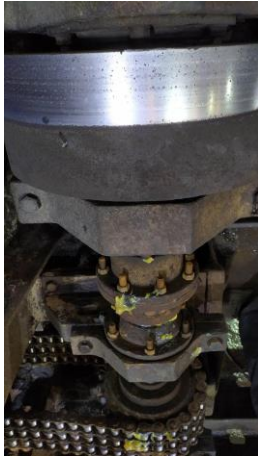
Picture 1: Location of the broken bearing

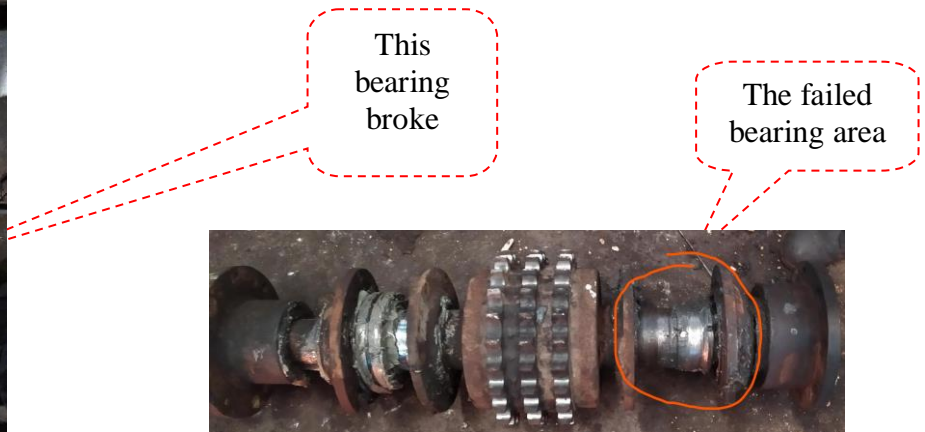
Picture 2: Drive shaft taken out after bearing failure.

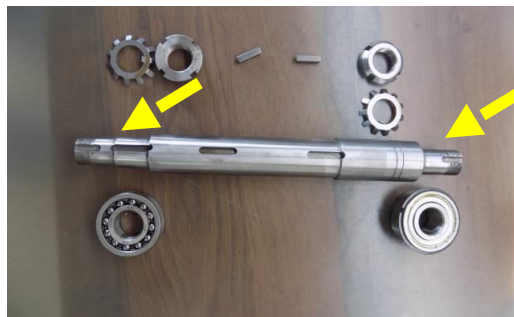
Picture: 3 Shaft with a key slot for lock washer locking

1: The shaft on which the bearing was mounted was in use for a long time and due to wear its threads were refurbished in the departmental machine shop. After machining the key slot was not made and not detected during assembly..

2: During assembly the fitter did not had the knowledge that the lock nut cannot be fitted without the lock washer so when he found no key slot in the shaft he discarded the washer and simple screwed in the lock nut.

1. After any machining in department machine shop there should be a procedure of inspection with the drawing and approval. This the departmental head has to initiate and bring under ISO documentation.
2. Fitters have to be trained on the function of lock washer and lock nut preferably with an One Point Lesson.(OPL)
3. A One Point Lesson has been made and enclosed with this report.
