KAIZEN RECORD SHEET

Kaizen Theme :

Location DIP HOT ZONE	Major equipment Group SPM-02 HOPPER	Equipment HOPPER TILTING HYDRAULIC VALVE	Problem Related To
---------------------------------	---	--	--------------------

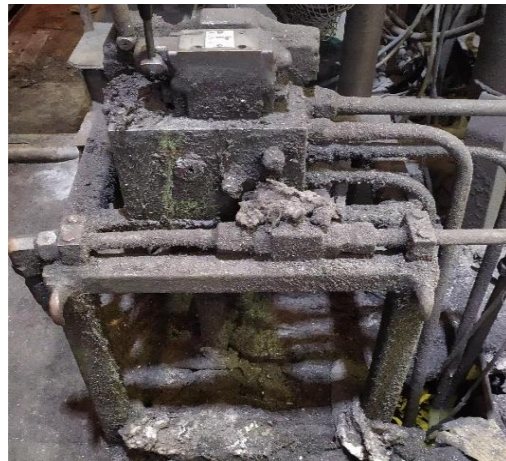
The valve stand is of SPM-02 Hopper and is located beside the hopper. The valve is exposed to heat and dust. Any leakages in the unit could not be detected because of the thick layer of dust.

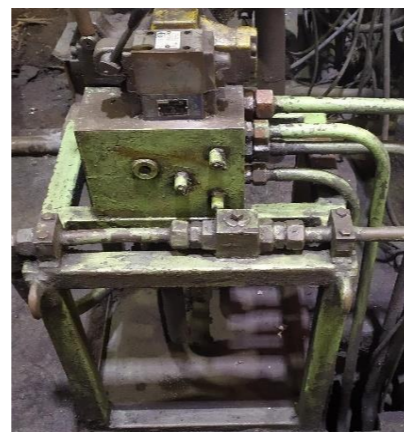
The valve after cleaning.

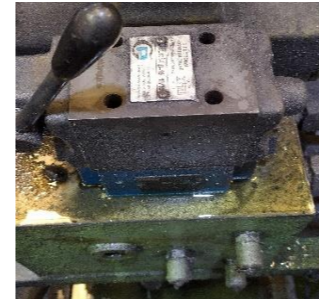
Huge leakage found at the base after cleaning.

Leakage stopped after C Oring replaciement. A tranparent cover made for the valve unit for dust protection.
